PHASE I FOUNDATION (PRE-POUR) INSPECTION REPORT

1455 Somewhere Ln, Anywhere, TX 71111
Inspection Prepared For: Jane Doe

Date of Inspection: 10/23/2019 - Time:
Year Built: - Size:
Weather: Overcast - 50 to 60 degrees

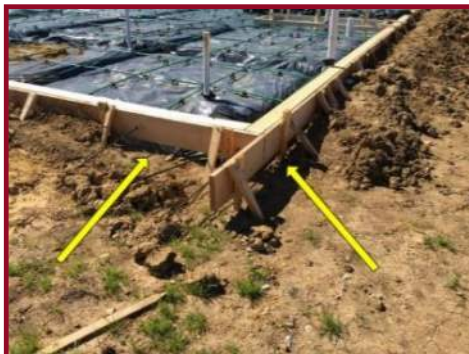
Large gaps were observed under the form boards. We recommend having this corrected to prevent the concrete from flowing out during its placement. This was observed on the Northwest Corner.

FILL NEEDED AROUND FORMS

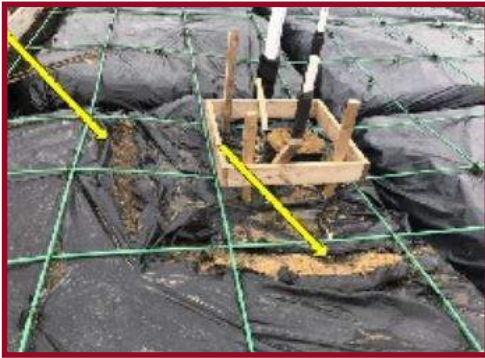
The **vapor barrier** has multiple holes/tears/opening at overlapped joints/under the drain pipes or on side beams etc... All opening in the barrier should be taped prior with a manufacturer approved tape prior to placing the concrete.

TEARS IN MOISTURE BARRIER

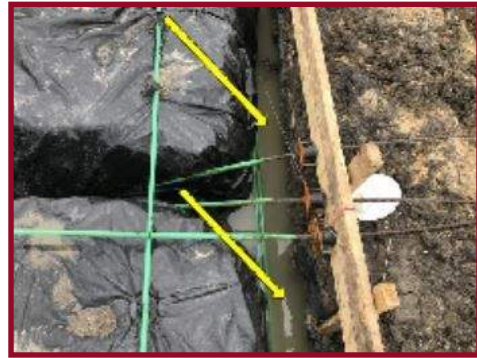
Water was found in the beams and will create an air pocket when the concrete is placed. This condition should be corrected with removal of all water.

WATER IN BEAM

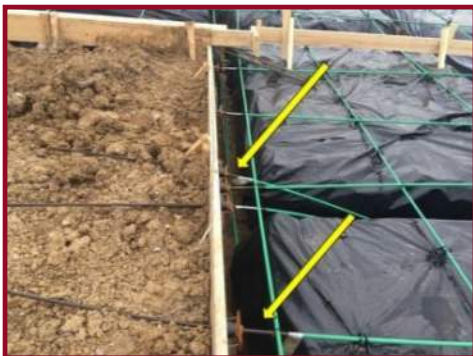
The sheathing on multiple tendons was damaged/ cut short and left the strands exposed to being in contact with the concrete. The tendons should be greased and taped prior to placing the concrete.

TENDONS NEED TAPING

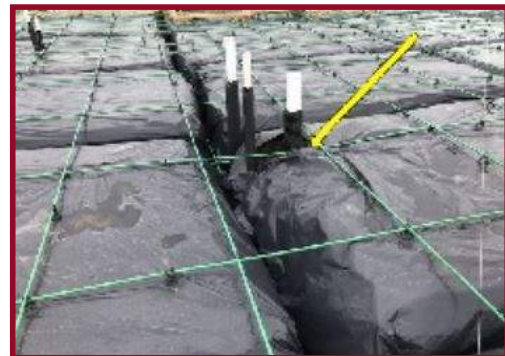
A tendon was found to be in contact with a PVC pipe (drain/vent). This could put stress on the piping when the tendons are put under tension, risking damage to the piping. Tendons should have 3" clearance from drain pipes and blockouts. This should be corrected prior to placing the concrete.

TENDON TOO CLOSE TO PIPE

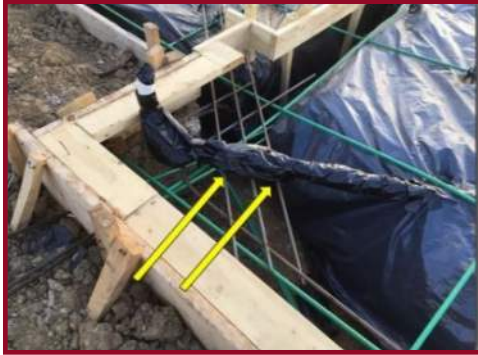
The PVC drain line is in contact with the rebar near the back porch area. The drain should be raised a minimum of 2 inches above the rebar prior to pouring concrete.

PLUMBING IN CONTACT WITH REBAR
