PROPERTY CONDITION REPORT

Client: Dr. John Doe
Property: 5832 Sometime Ln, Anywhere, TX 7111
Year Built: 2014 - Size: 5,853 square feet

Date of Inspection: 10/31/2020 - Time: 10:00 AM
Weather: Sunny - 60 to 70 degrees

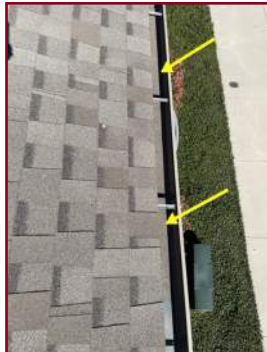
The roof gutters were observed to have an accumulation of roofing material granules. Gutters require cleaning.

GRANULES IN GUTTER

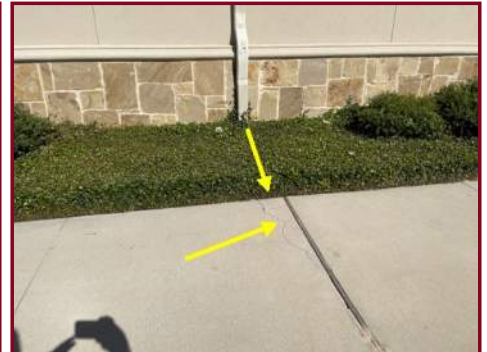
The downspouts around the subject building handle a large volume of water when raining. Large areas of erosion creating depressions were observed in various locations around the building. These areas are allowing water to pond or stand next to the foundation. Water should not be allowed to stand near a foundation for more than 24 hours. Extensions should be added to the downspouts allowing water to drain away from the foundation.

DOWNSPOUTS SHOULD BE EXTENDED TO SIDEWALK

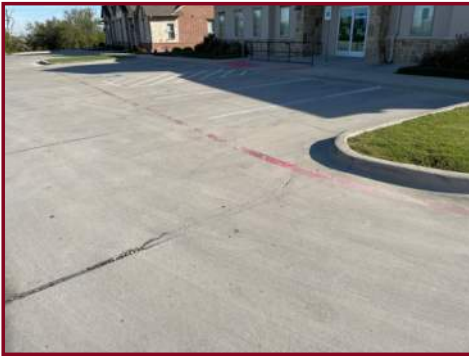
Parking lot striping was observed to be fading or flaking at the time of this inspection. Striping should be painted in the near future.

STRIPING IS FADING

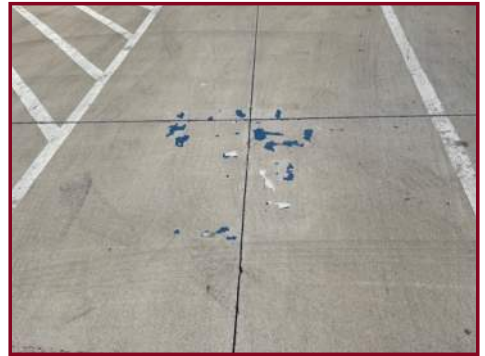
FADED HANDICAP SIGN

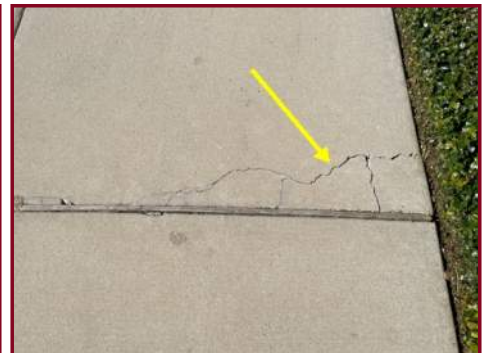
Minor cracks and/or deficiencies were observed in the sidewalk on the south side and the east side of the structure.

CRACKED/DAMAGED SIDEWALK ON SOUTH SIDE

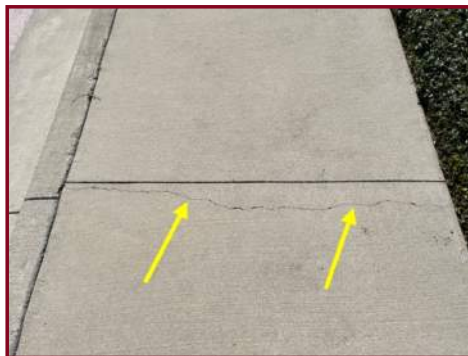
CRACK IN SIDEWALK ON EAST SIDE

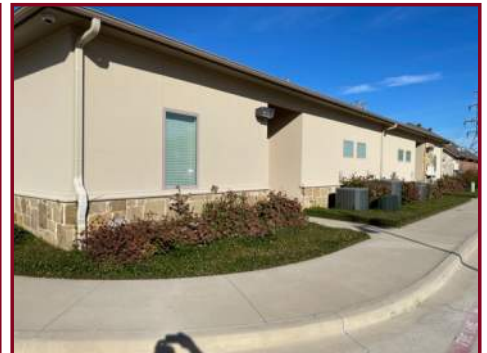
The landscaping needs trimming or pruning. The heavy foliage around the structure should be cut back to allow full view of the exterior walls.

HEAVY FOLIAGE ON NORTH SIDE

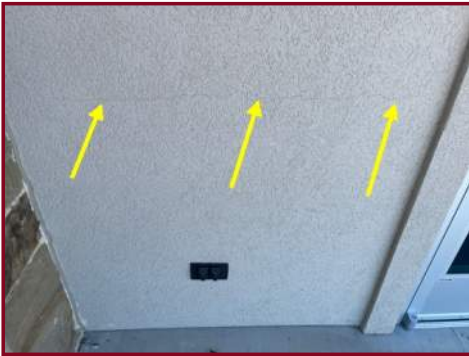
SMALL CRACK IN STUCCO

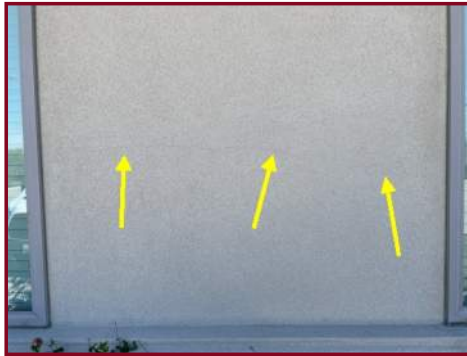
SMALL CRACKS IN STUCCO

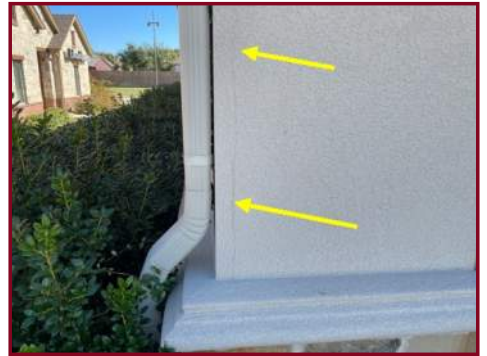
CRACK IN STUCCO AT NORTHWEST CORNER

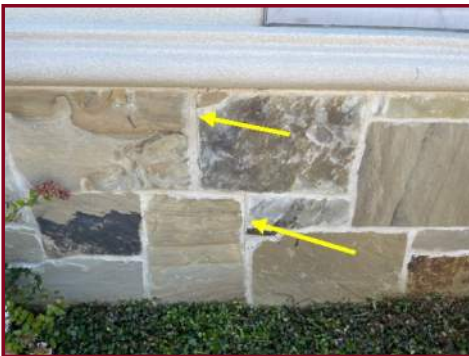
THERMAL EXPANSION CRACK IN STONE VENEER AT SOUTHWEST CORNER

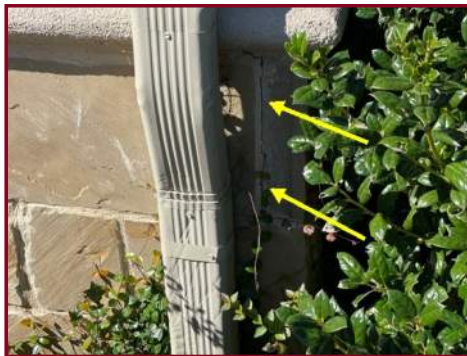
THERMAL EXPANSION CRACK IN STONE VENEER AT NORTHEAST CORNER

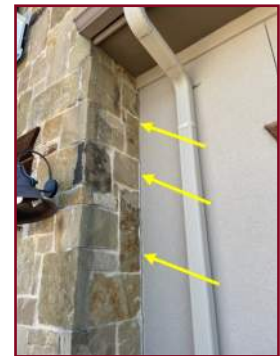
JOINT NEEDS SEALING BETWEEN STONE VENEER AND STUCCO

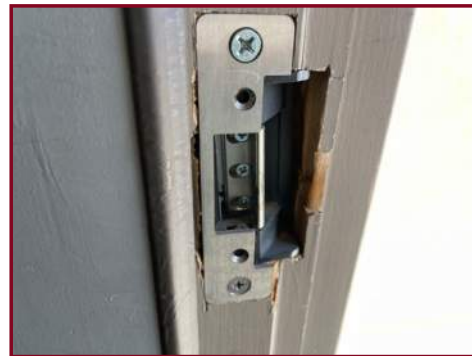
The **strike plate** to the south exit door on the east side was observed to have some screws

missing. Condition should be further evaluated and corrected as necessary.

STRIKE PLATE MISSING SCREWS ON SOUTH REAR EXIT DOOR

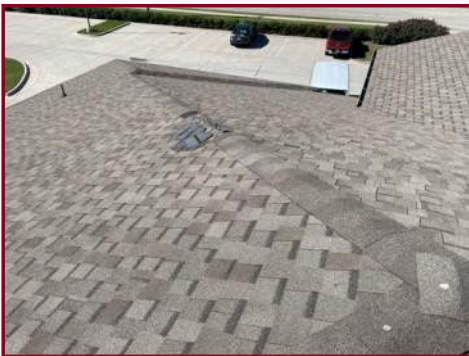
DAMAGED RIDGE CAP ON SOUTHWEST CORNER HIP

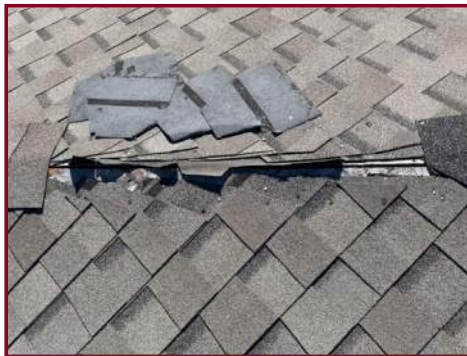
DAMAGED RIDGE CAP ON SOUTHWEST CORNER HIP

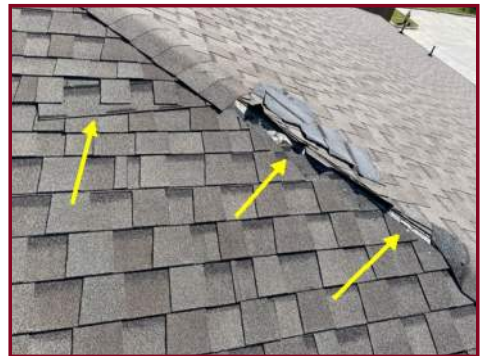
SHINGLE PULLING LOOSE AND DAMAGED RIDGE CAP ON SOUTHWEST CORNER HIP

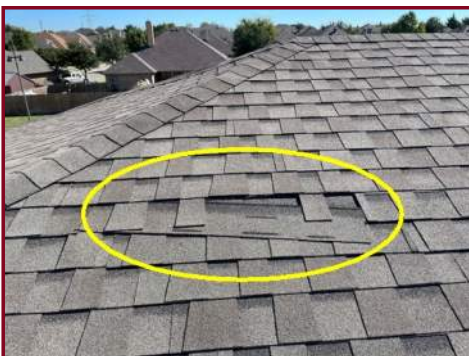
Some shingle tabs were observed to be sliding out of place on the west side of the structure.

SHINGLE TAB SLIDING OUT OF PLACE

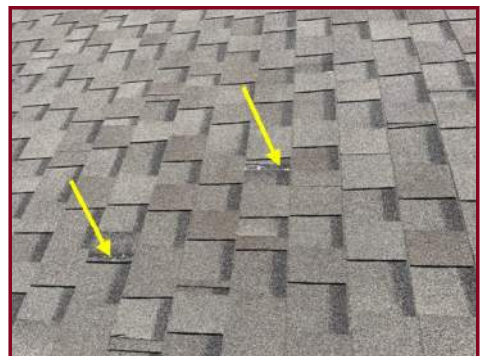
Damaged shingles were observed on the East Side of the roof structure.

DAMAGED SHINGLE TABS ON EAST SIDE OF ROOF

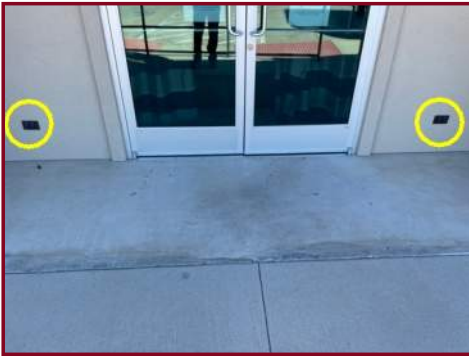
The exterior **receptacle**s do not appear to be connected to a ground fault circuit interrupter (GFCI) device. Under current electrical standards, all of the exterior receptacles should have GFCI protection.

NO GFCI ON EXTERIOR RECEPTACLES

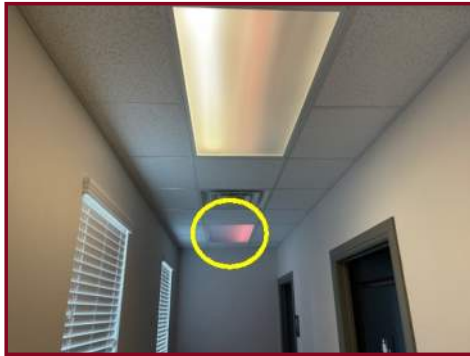
One or more of the light fixtures appear to be inoperative in the public restroom hallway, the fitting room, the south hallway, the rear hallway, and the attic. This may be due to a bad bulb or some other unknown condition. This condition should be further evaluated and corrected as necessary.

INOPERABLE LIGHT FIXTURE IN PUBLIC RESTROOM HALLWAY

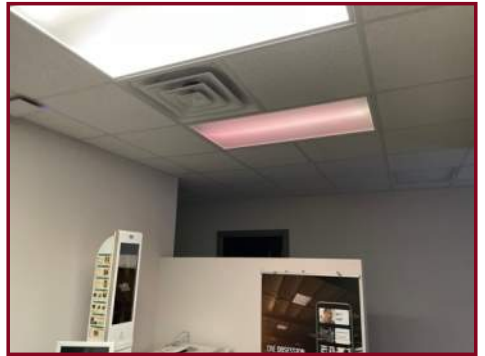
INOPERABLE LIGHT FIXTURE IN FITTING ROOM

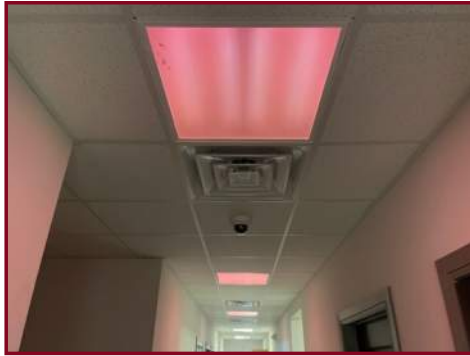
INOPERABLE LIGHT FIXTURES IN REAR HALLWAY

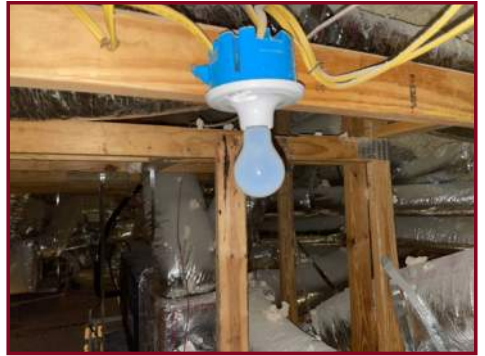
INOPERABLE LIGHTS IN ATTIC

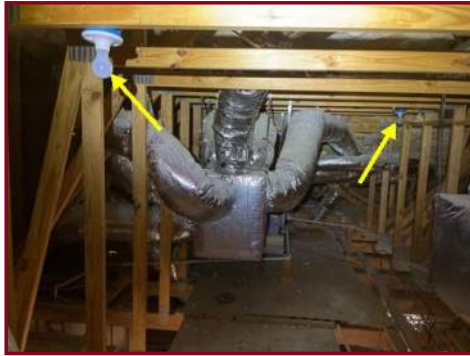
INOPERABLE LIGHT FIXTURES IN ATTIC

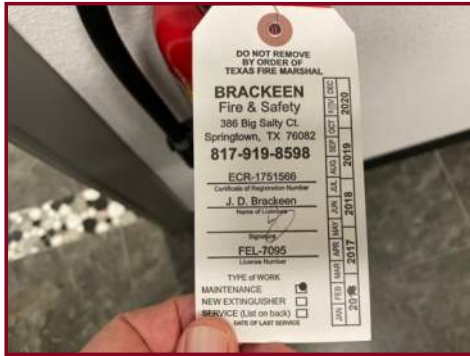
Inspection Tags were observed to be out of date.

FIRE EXTINGUISHER INSPECTION TAG

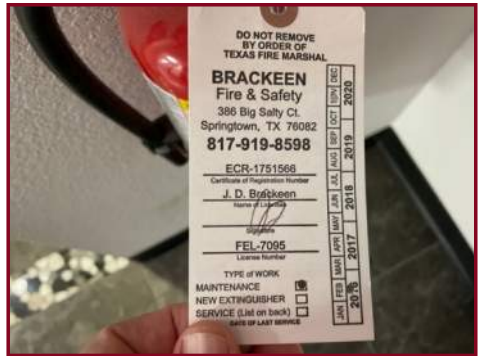
FIRE EXTINGUISHER INSPECTION TAG

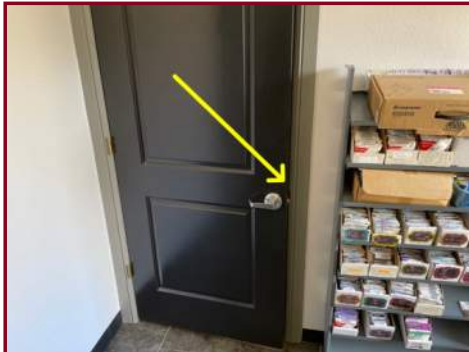
DOOR NOT LATCHING TO REAR HALLWAY

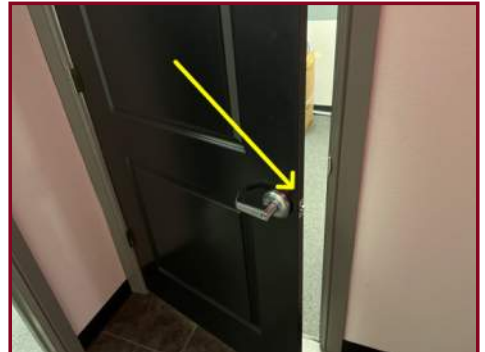
DOOR NOT LATCHING TO ELECTRICAL ROOM

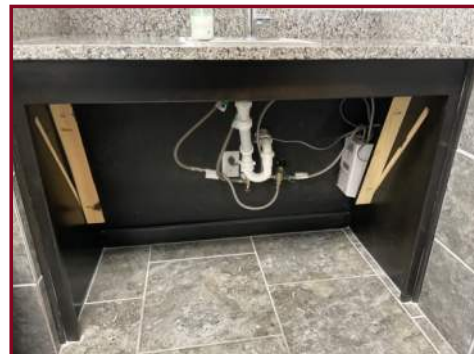
The false front covering the plumbing pipes was observed to be missing to the lavatory in the rear employees restroom.

EMPLOYEES RESTROOM LAVATORY CABINET WAS MISSING THE COVER
