PROPERTY INSPECTION REPORT

Client: John Doe
Inspection Address: 2119 Anywhere St
Somewhere, TX 75555
Year Built: 2008 - Size: 2,314 square feet

Date of Inspection: 11/7/2019 - Time: 9:00 AM
Weather: Sunny 60 to 70 degrees

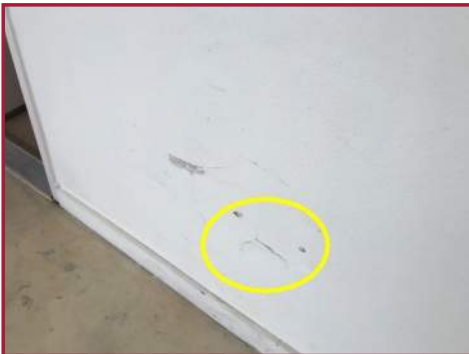
Minor impact damage was observed on the back wall in the garage.

IMPACT DAMAGE IN GARAGE

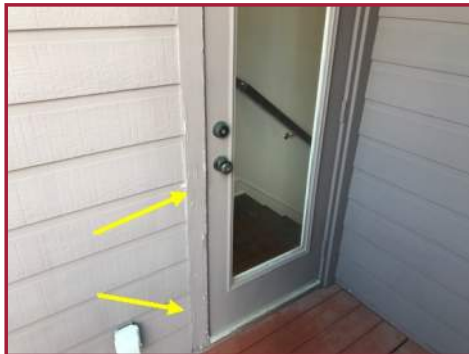
PAINT NEEDED AROUND DOOR JAMB TO ROOFTOP DECK

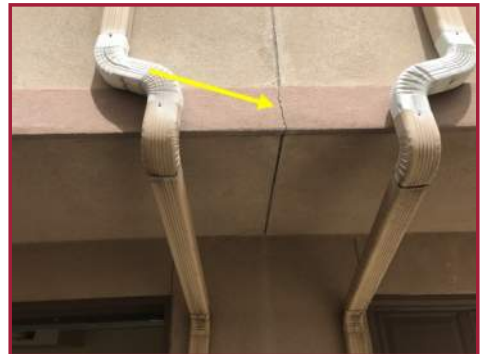
CRACK IN EIFS STUCCO BAND OVER EAST SIDE OF GARAGE DOOR

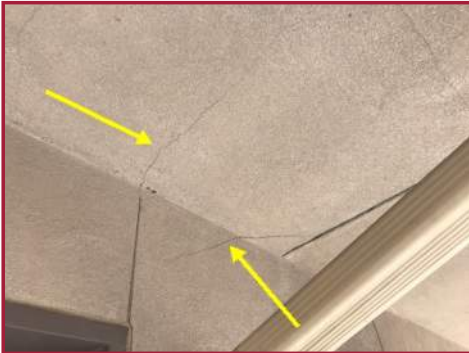
CRACKS IN EIFS STUCCO OVER EAST SIDE OF GARAGE DOOR

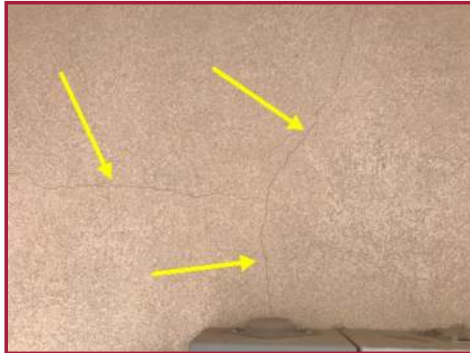
Minor cracks in EIFS (stucco) were observed on the south side. All cracks in EIFS should be sealed to help prevent water penetration/entrapment.

CRACKS IN EIFS ON SOUTH SIDE OF STRUCTURE ABOVE ELECTRIC METER BOX

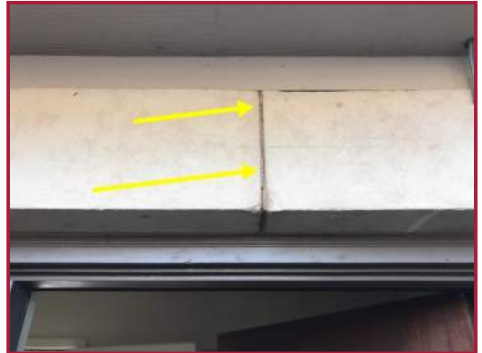
Cast stone over front entry has minor settlement causing a crack in the mortar. Mortar should be tuckpointed.

CRACK IN CAST STONE GROUT OVER FRONT ENTRY

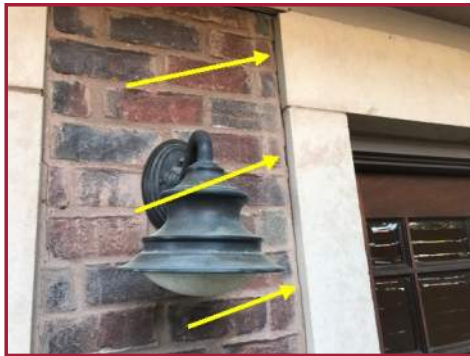
MINOR CRACKS IN MORTAR AROUND CAST STONE ENTRY

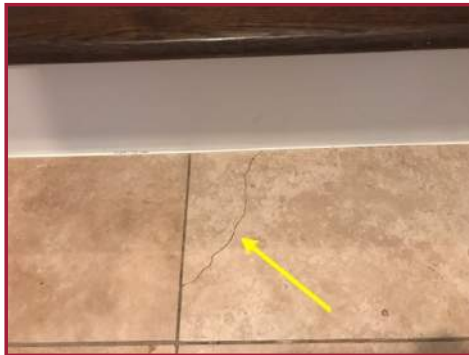
The floor tile(s) were observed to be cracked and/or damaged in front entry.

CRACKED/DAMAGED FLOOR TILE AT BASE OF FIRST FLOOR STAIRWAY

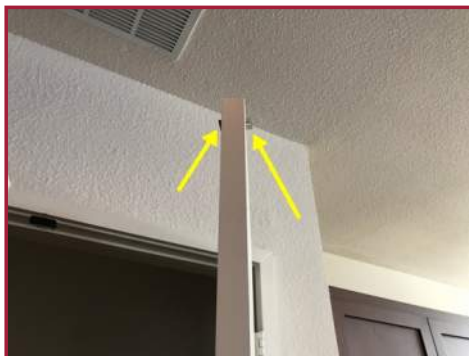
The door spring latch(es) are damaged and/or missing to the pantry.

DAMAGED SPRING LATCH TO PANTRY DOOR

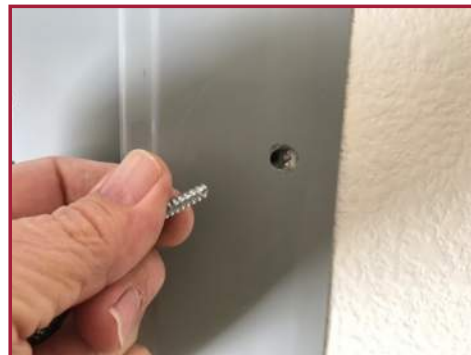
The electrical cabinet cover plate (dead front) should be installed with blunt tip screws and not sharp wood type screws for reasons of safety.

SHARP POINTED SCREWS ON PANEL COVER

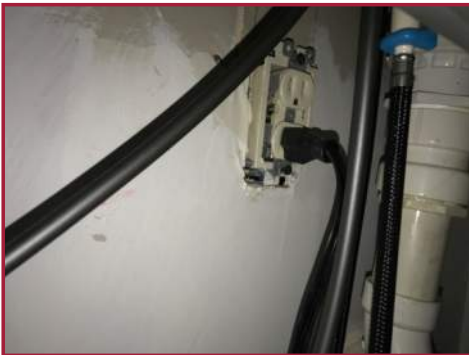
One or more of the receptacles is missing its cover plate in the various locations throughout the house (See Pictures).

MISSING RECEPTACLE COVER UNDER KITCHEN SINK

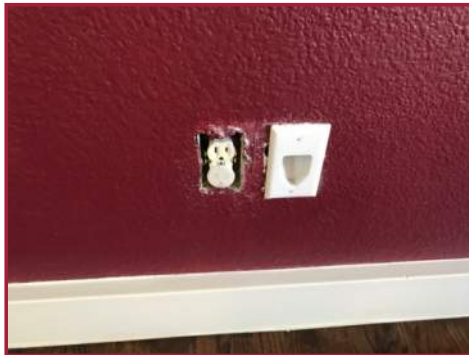
MISSING RECEPTACLE COVER IN LIVING ROOM

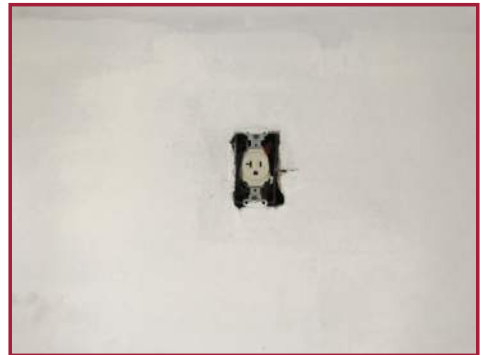
MISSING RECEPTACLE COVER IN ROOFTOP STORAGE CLOSET

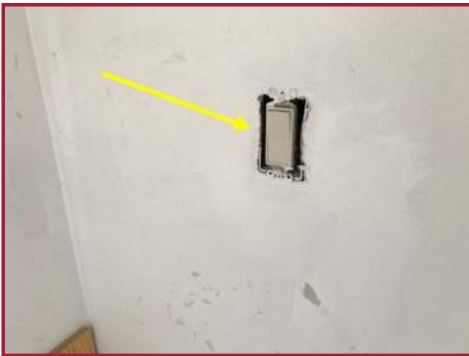
The switch is missing its cover plate in the roof deck storage closet.

MISSING SWITCH PLATE COVER IN ROOFTOP STORAGE CLOSET

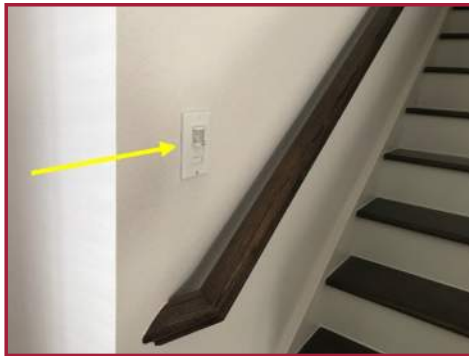
The motion detector light switch to the second level stairway light was not operating correctly at the time of this inspections. Condition should be further evaluated and corrected as necessary.

MOTION DETECTOR ON SECOND LEVEL STAIRWAY NOT PERFORMING CORRECTLY

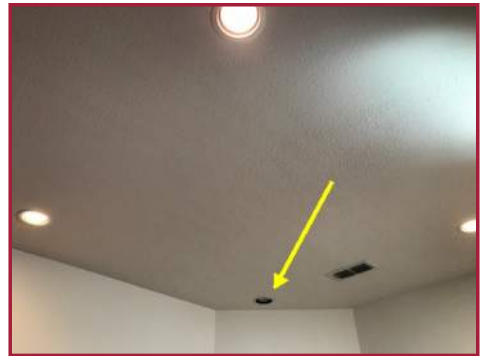
One or more of the light fixtures appear to be inoperative in the various locations throughout the house (See Pictures). This may be due to a bad bulb or some other unknown condition. This condition should be further evaluated and corrected as necessary.

INOPERATIVE LIGHT FIXTURE IN STUDY

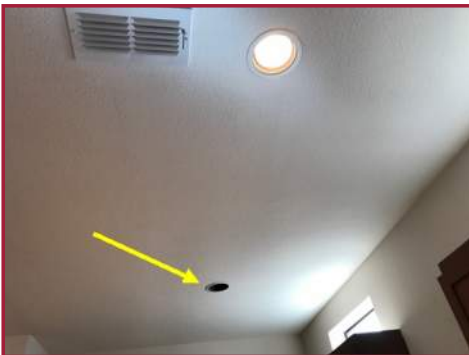
INOPERATIVE LIGHT FIXTURE IN KITCHEN

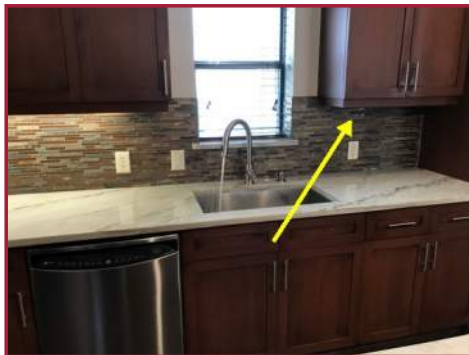
INOPERATIVE LIGHT FIXTURE RIGHT OF KITCHEN SINK

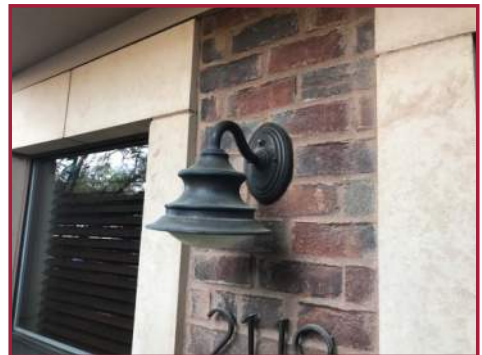
INOPERATIVE LIGHT FIXTURE AT FRONT PORCH/ENTRY

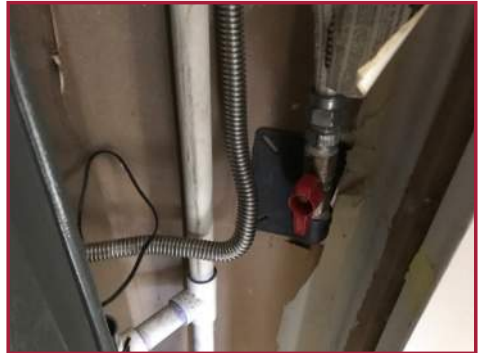
The heater gas supply line to the upstairs heating unit is not equipped with a **sediment trap** just before the gas appliance connector. This condition does not meet current installation requirements. This is an **as-built** condition, but Per TREC standards of practice we are required to report this condition as a deficiency. Some items reported as Deficient may be considered upgrades to the property. For more information, refer to Texas Real Estate Consumer Notice Concerning Recognized Hazards, form OP-I.

NO SEDIMENT TRAP ON UPSTAIRS UNIT

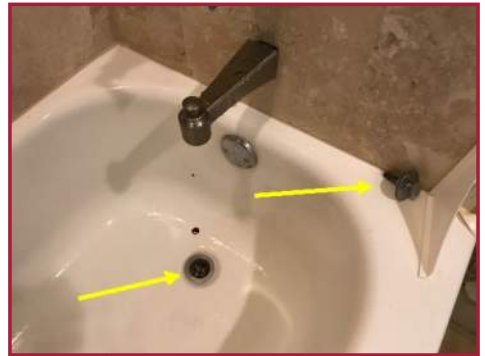
STOPPER IS DAMAGED TO DOWNSTAIRS BEDROOM BATHTUB

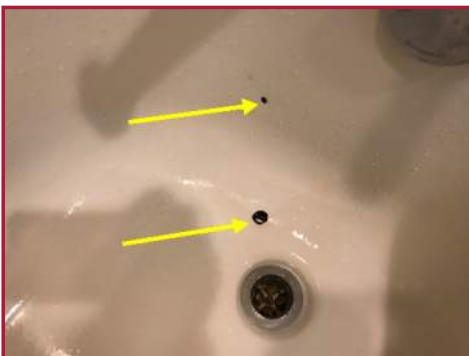
BATHTUB HAS SURFACE DAMAGE IN DOWNSTAIRS BEDROOM BATHROOM

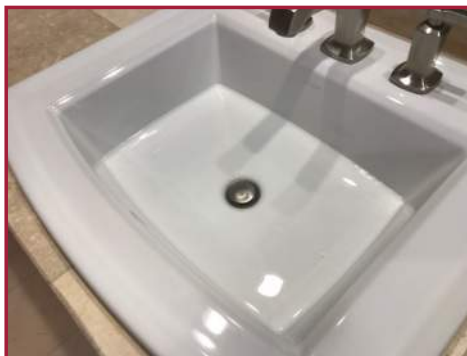
The left lavatory sink was observed to drain slowly, suggesting that an obstruction may exist in the master bathroom. This condition should be further evaluated and corrected as necessary.

SINK DRAINS SLOWLY AT SOUTH VANITY IN MASTER BATHROOM

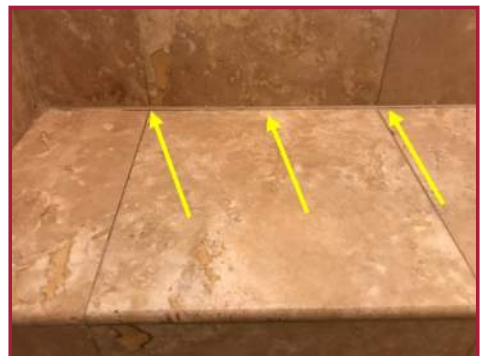
Cracked, deteriorated and/or missing shower stall grout and/or caulking should be repaired or replaced as necessary in the master bathroom.

CRACKED/DETERIORATED SHOWER GROUT IN MASTER BATHROOM

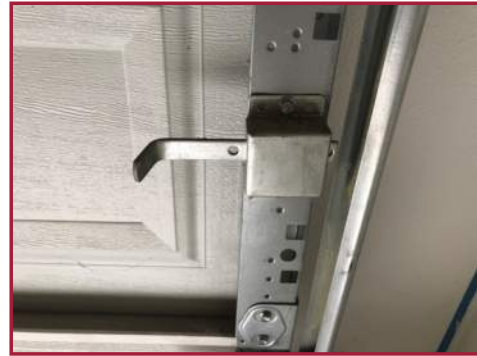
When an automatic garage door opener is in use, the manual lock should be disabled or removed.

MANUAL LOCK SHOULD BE DISABLED OR REMOVED

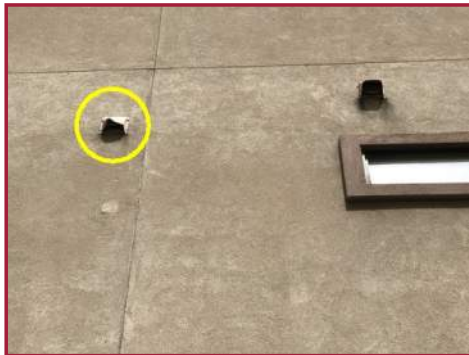
The exterior dryer duct termination cover is damaged.

DAMAGED EXHAUST VENT ON SOUTH SIDE OF STRUCTURE
