PHASE II (PRE-DRYWALL) INSPECTION REPORT

1234 Somewhere Ln, Anywhere, TX 71111 Inspection Prepared For: John Smith

Date of Inspection: 11/26/2019 - Time: 9:00 AM Year Built: - Size: Weather: Sunny - 70 to 80 degrees

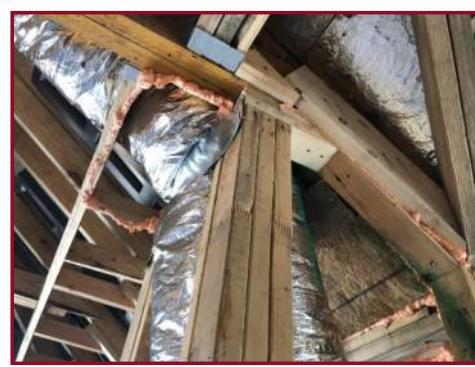
The triple studs supporting the intersection of the beams and roof valley rafter over the game room area upstairs do not have proper support from beams or joists over the dining room area below. Condition should be further evaluated and corrected as necessary.

TRIPLE STUDS SUPPORTING INTERSECTION OF JOIST BEAMS AND ROOF RAFTERS

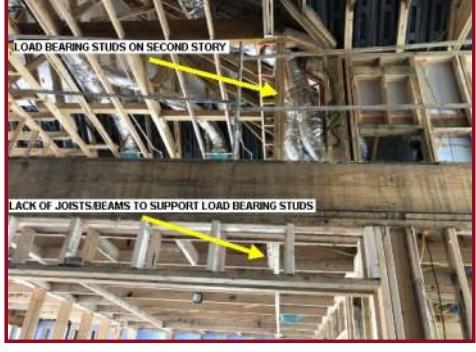
LACK OF PROPER BEAM SUPPORT FOR LOAD BEARING STUDS

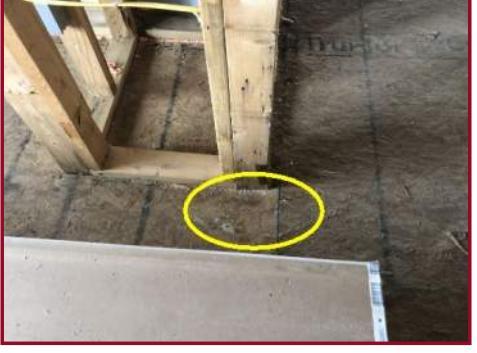
DECKING SAGGING UNDER LOAD BEARING STUDS FROM LACK OF SUPPORT BEAMS BELOW

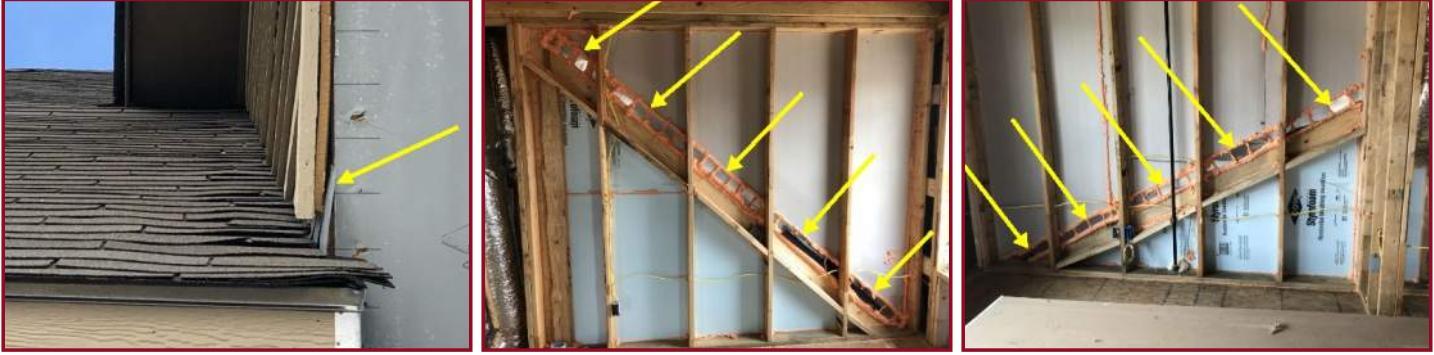
The step flashing down the rake where the exterior siding meets the roof appears to have been installed prior to installation of the exterior insulation board. The step flashing should be installed between the exterior insulation board and the exterior siding. This type of step flashing installation does not provide proper backing for the flashing as well as proper insulating factors and has potential for water intrusion. Condition should be further evaluated and corrected as necessary.

STEP FLASHING BEHIND EXTERIOR SHEATHING IMPROPER FLASHING INSTALLATION

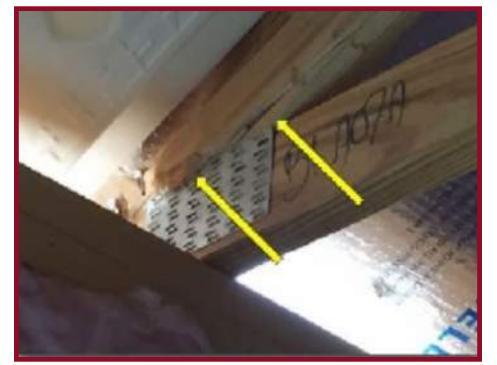
The top chord on the 4th truss in the side middle bedroom is twisted and split where it meets the pottom chord. A scab or plywood gusset should be added.

DAMAGED TOP CHORD TO TRUSS

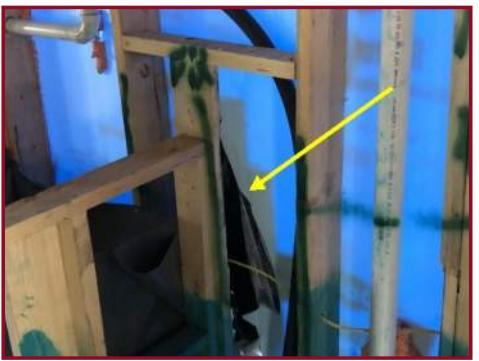
Holes/tears were observed in the exterior sheathing. We recommend replacing damaged sheathing. This was observed on the North Side of the structure.

EXTERIOR SHEATHING DAMAGE ON NORTH EXTERIOR SHEATHING DAMAGE ON NORTH SIDE OF MASTER BATHROOM

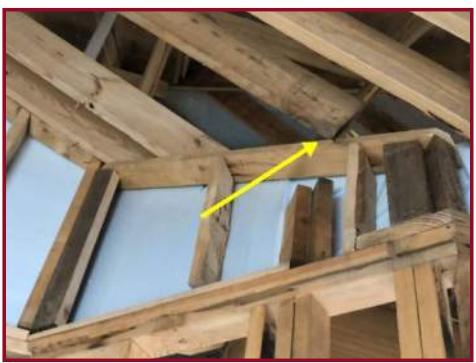
One of the joist/rafters on the cathedral ceiling over the master bathroom was observed to be too short and does not have proper bearing on the top plate.

JOIST IS TOO SHORT AND DOES NOT HAVE PROPER BEARING

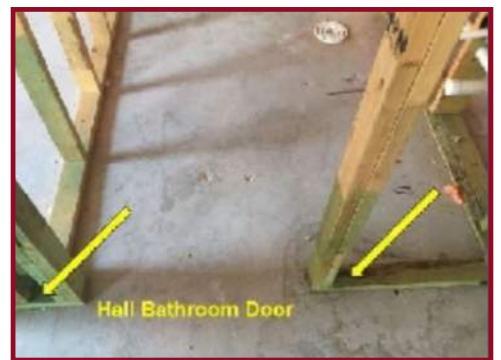
The sill plate next to doors should be secured on both sides to prevent movement when opening/closing doors. Doors that lack proper securing are located in the Hall Bathroom.

SILL PLATES NEED TO BE SECURED ON BOTH SIDES OF DOOR

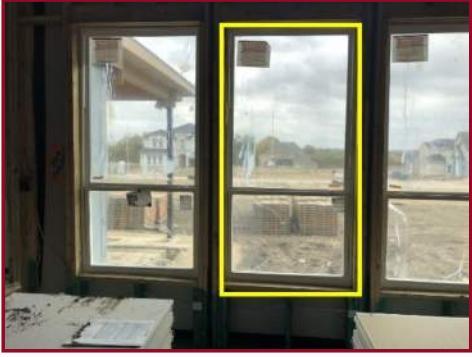
A window was out of square with the opening. We recommend repair/adjustment prior to hanging the sheetrock. This was found in the Living Room.

WINDOW OUT OF SQUARE WITH OPENING

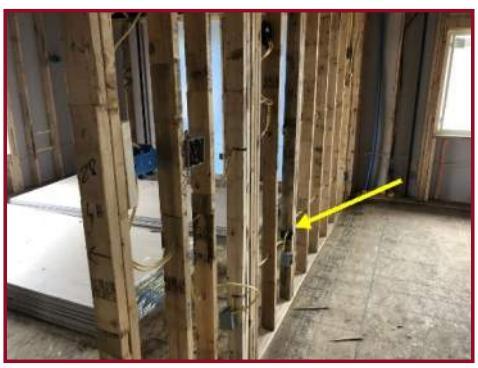
Protective **puncture plates** were missing in various locations. These are required when the bored hole for the conductor is with in 1.25" of the edge of the stud. We recommend having these added. This was observed in the Dining Room.

PROTECTIVE WIRING PLATES NEEDED IN DINING ROOM

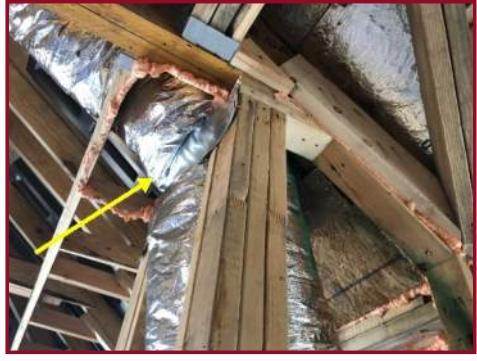
A damaged and restricted duct was noted. This could prevent proper air flow. We recommend having this repaired/improved. This was noted at the top of the stairs.

DUCTWORK CRIMPED AT TOP OF STAIRWAY
