PROPERTY INSPECTION REPORT

Client: John Doe
Inspection Address: 2119 Anywhere St
Somewhere, TX 75555
Year Built: 2008 - Size: 2,314 square feet

Date of Inspection: 11/7/2019 - Time: 9:00 AM
Weather: Sunny 60 to 70 degrees

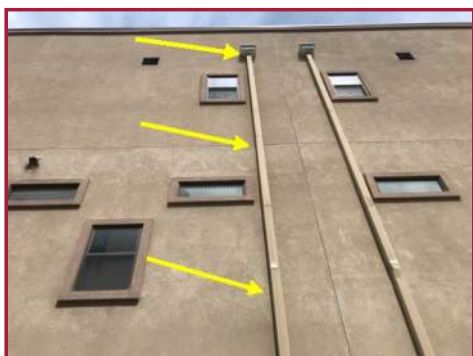
ROOF SCUPPER AND DOWNSPOUT TO ROOF DRAIN

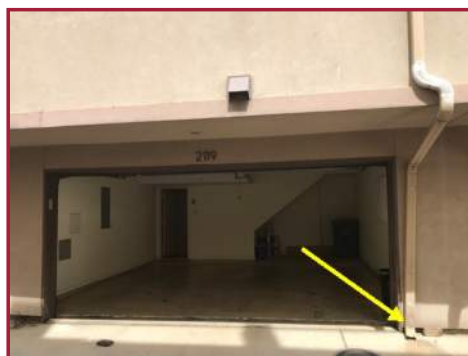
ROOF DRAIN EXIT ONTO ALLEYWAY

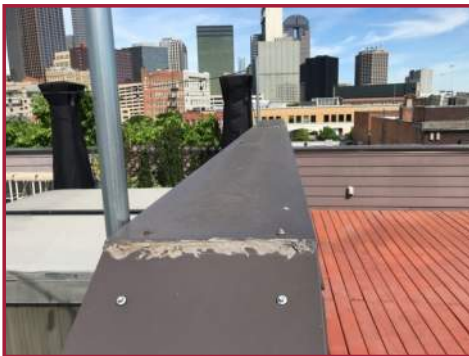
CAP FLASHING ON PARAPET WALL

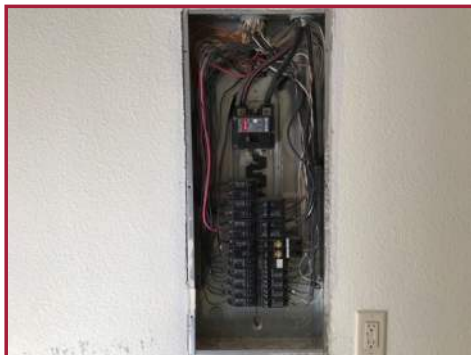
MAIN PANEL WITH COVER REMOVED FOR INSPECTION

The electrical cabinet cover plate (dead front) should be installed with blunt tip screws and not sharp wood type screws for reasons of safety.

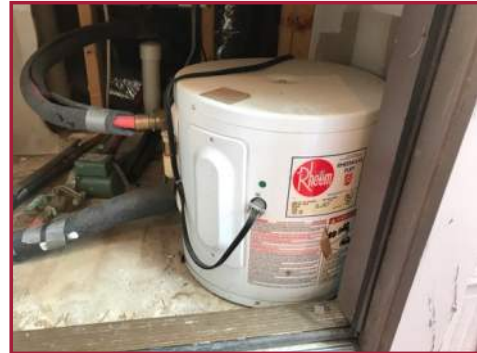
THERMOSTAT TO WATER HEATER IN ROOFTOP WATER HEATER CABINET

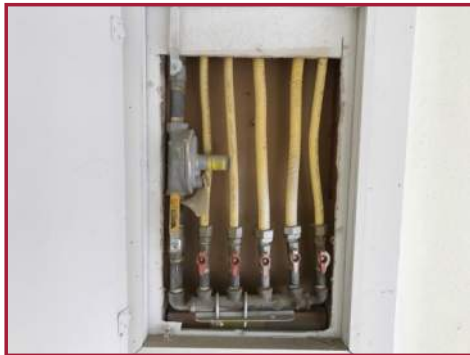
Corrugated Stainless Steel Tubing (**CSST**) was observed to be in use at the time of this inspection. This product is known to have various installation and grounding/**bonding** problems or deficiencies. I was unable to locate a point of grounding or bonding for this product. You are strongly encouraged to have a licensed plumber evaluate the installation and a licensed electrician investigate for proper bonding and grounding of this component of the gas distribution system. Such follow-up should take place prior to the expiration of any time limitations such as option or warranty periods. Evaluations by qualified tradesmen may lead to the discovery of additional deficiencies which may involve additional repair costs.

CSST GAS PIPING MANIFOLD
