PROPERTY CONDITION REPORT

Client: Dr. John Doe
Property: 5832 Sometime Ln, Anywhere, TX 7111
Year Built: 2014 - Size: 5,853 square feet

Date of Inspection: 10/31/2020 - Time: 10:00 AM
Weather: Sunny - 60 to 70 degrees

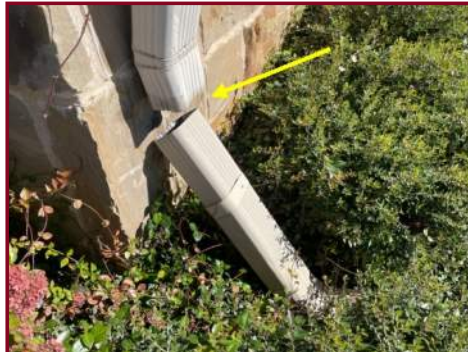
GUTTER DOWNSPOUT SEPARATED AT SOUTHWEST CORNER

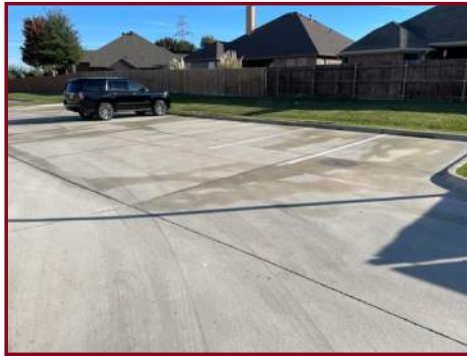
STRIPING IS FADING

STRIPING

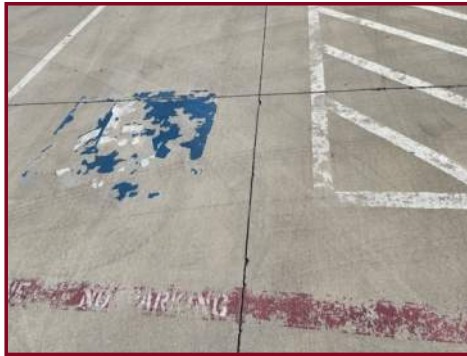
FADED PARKING STRIPING

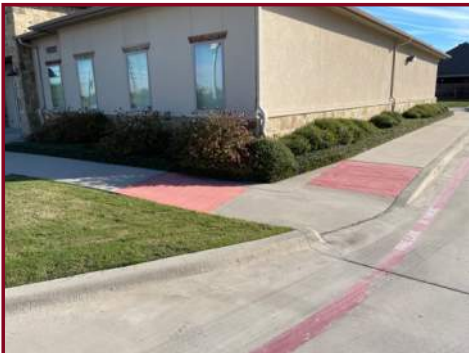
LANDSCAPING

The landscaping needs trimming or pruning. The heavy foliage around the structure should be cut back to allow full view of the exterior walls.

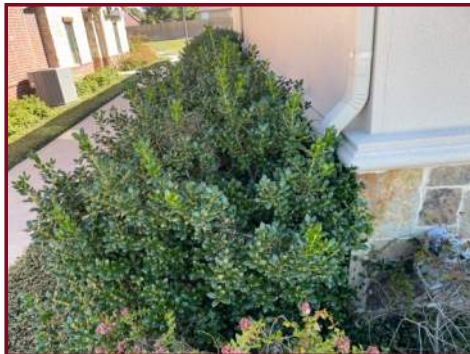
HEAVY FOLIAGE ON NORTH SIDE

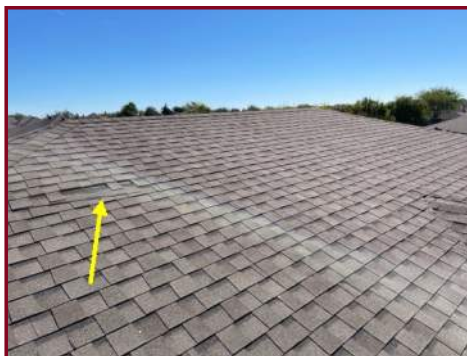
SHINGLE TAB SLIDING OUT OF PLACE

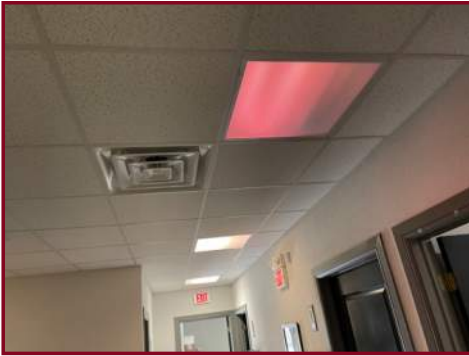
INOPERABLE LIGHT FIXTURE IN SOUTH HALLWAY

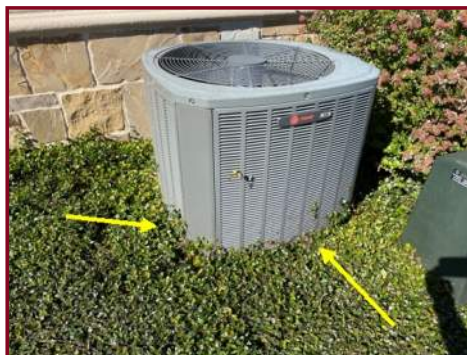
Heavy foliage around the exterior cooling system units can restrict air flow through the

condensing coils causing the system to become inefficient. Foliage should be trimmed away from **condensing units** at all times.

HEAVY FOLIAGE AROUND COOLING UNITS

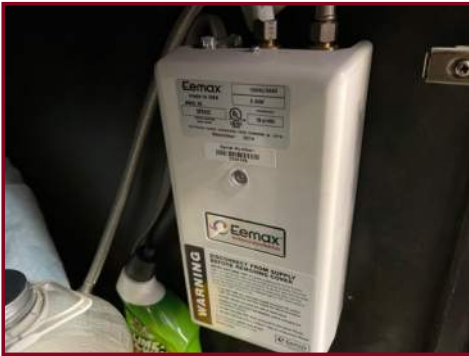
The water heaters were not functioning properly at several locations throughout the structure. Condition should be further evaluated by a licensed plumber.

TYPICAL UNDERCOUNTER
WATER HEATER

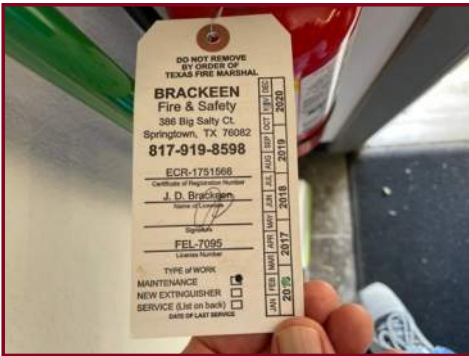
Inspection Tags were observed to be out of date.

FIRE EXTINGUISHER INSPECTION TAG

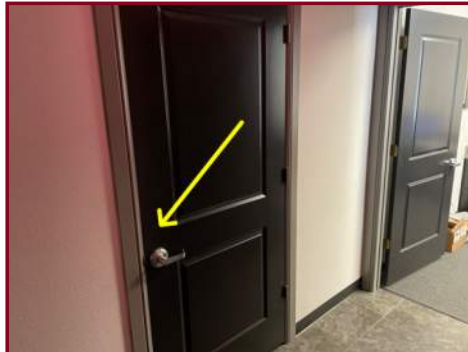
EAST STORAGE CLOSET DOOR IN REAR HALLWAY NOT LATCHING PROPERLY

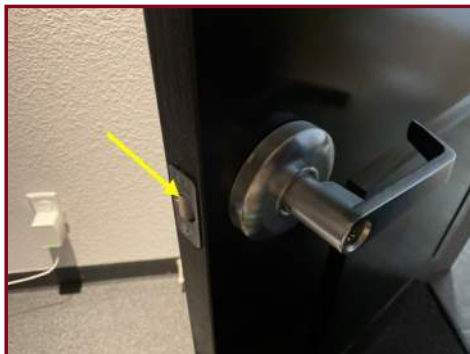
PLUNGER STUCK ON DOOR TO COMPUTER ROOM
