PROPERTY INSPECTION REPORT

Client: John Doe
Inspection Address: 2119 Anywhere St
Somewhere, TX 75555
Year Built: 2008 - Size: 2,314 square feet

Date of Inspection: 11/7/2019 - Time: 9:00 AM
Weather: Sunny 60 to 70 degrees

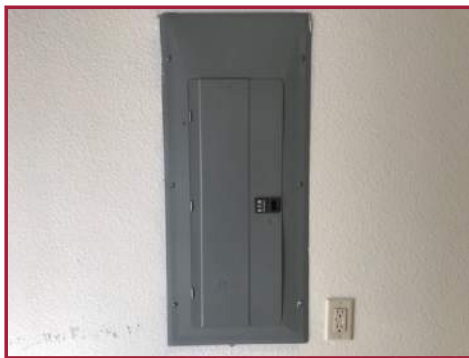
MAIN PANEL

The electrical cabinet cover plate (dead front) should be installed with blunt tip screws and not sharp wood type screws for reasons of safety.

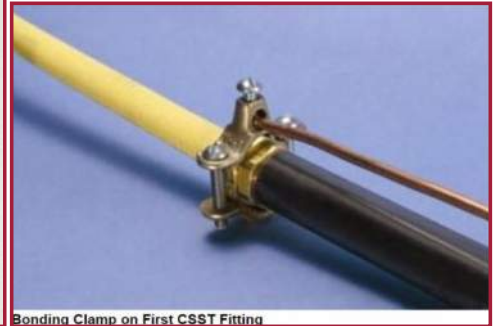
Bonding Clamp on First CSST Fitting

PROPER CSST PIPING GROUNDING INSTALLATION

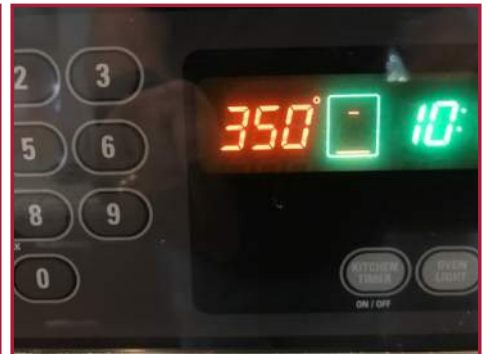
The temperature of the oven was checked at 350 degrees. The temperature rose to 345 degrees and held that temperature. This temperature range of 25 degrees +/- of set temperature falls within acceptable industry standards.

OVEN TEMPERATURE SETTING AT TIME OF TEST

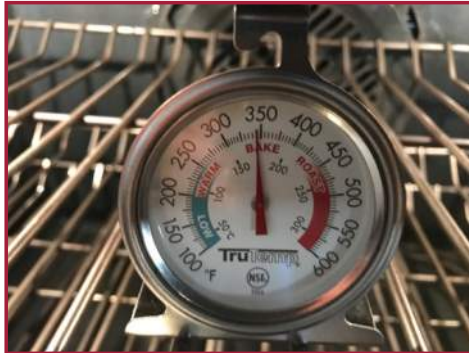
OVEN TEMPERATURE READING AT TIME OF TEST

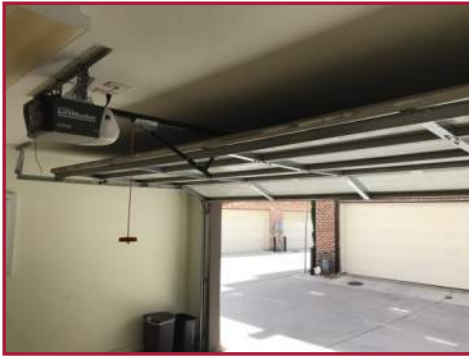
GARAGE DOOR OPERATOR

This component appears to be performing adequately at the time of this inspection.

When an automatic garage door opener is in use, the manual lock should be disabled or removed.
